## Housing Plus Image Gallery

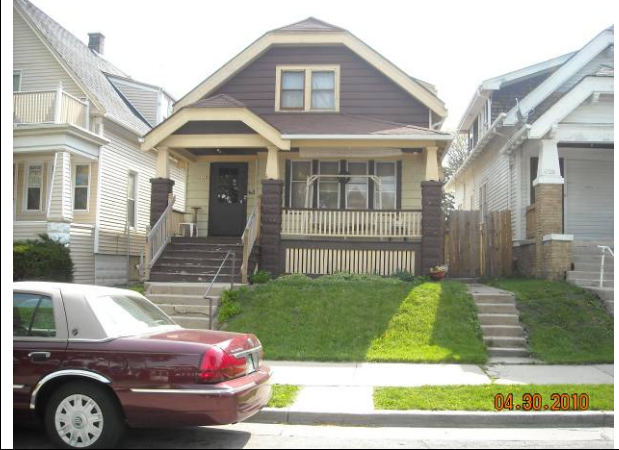
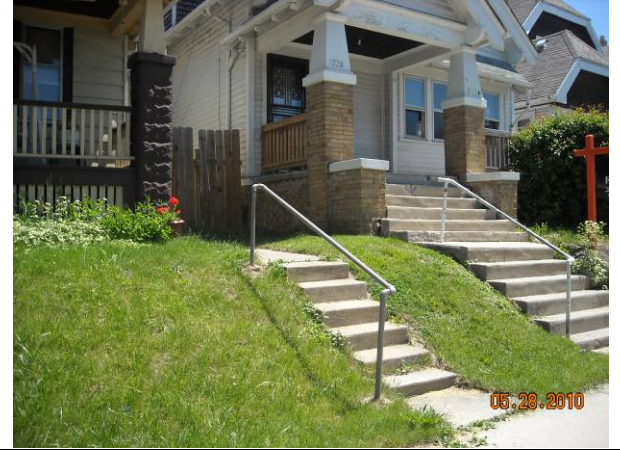
<p>This home needed a railing for the stairs to the backyard. The picture on the left reveals the stairway without a railing and the picture on the right reveals the railing installed.</p>

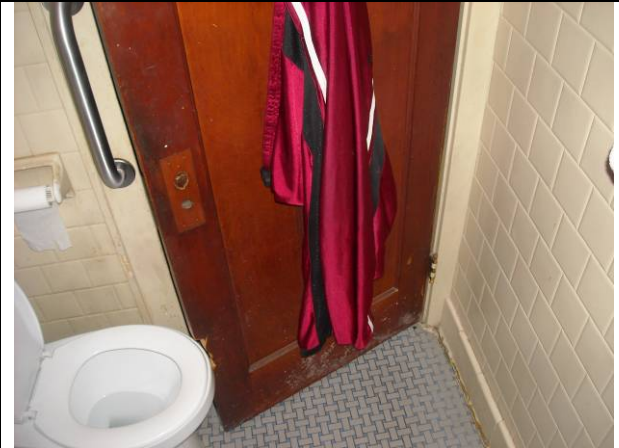
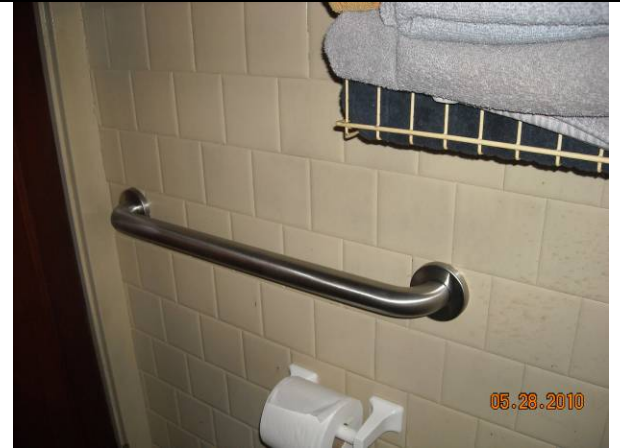
<p>This homeowner had difficulty sitting down on the toilet due to decreased lower body strength and the toilet paper roll and grabber that projected into their personal space. The picture on the right reveals the new placement of the toilet paper roll and grabber to allow the homeowner to comfortably use the restroom.</p>

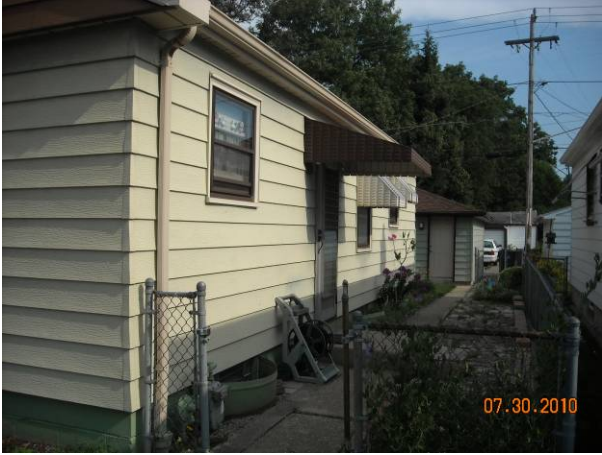
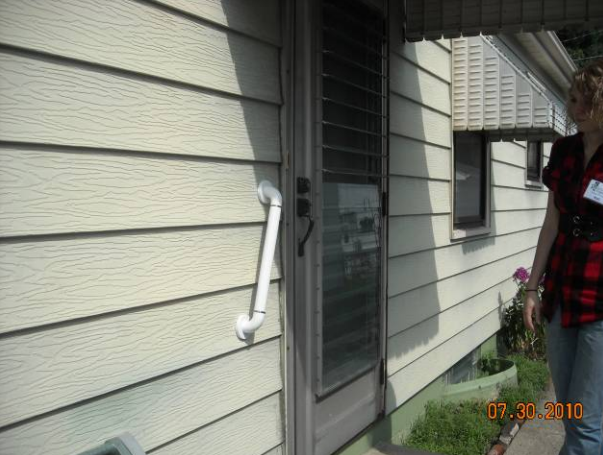
<p>07.30.2010</p>	<p>The homeowner had difficulties entering and leaving their home because of the step leading to their door. The picture on the right shows a grab bar added to the exterior of the house. This grab bar provides support for the homeowner to safely enter and exit the house.</p>

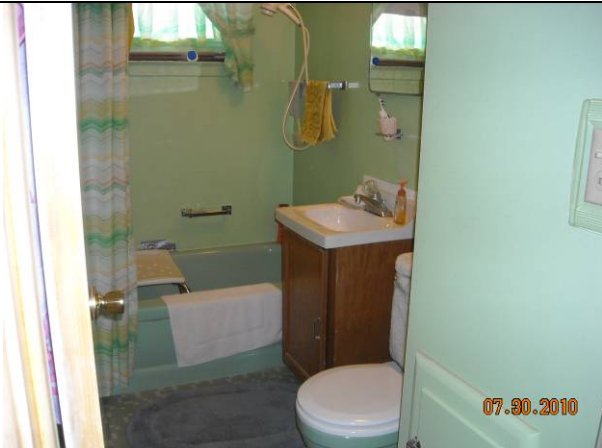
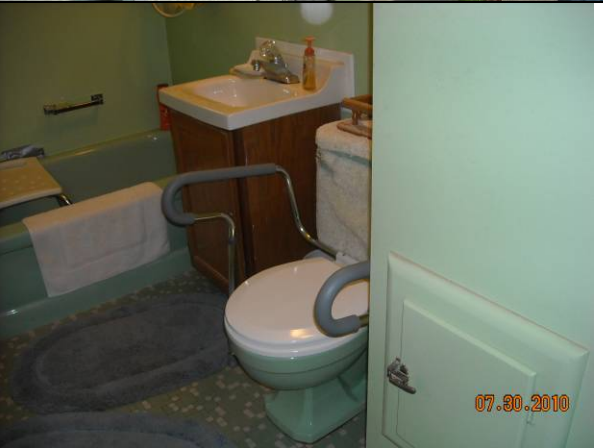
<p>07.30.2010</p>	<p>The homeowner was unable to easily get on and off the toilet due to decreased lower body strength. The installation of a toilet safety frame allows the homeowner to use their upper body to help them get on and off the toilet without strain.</p>

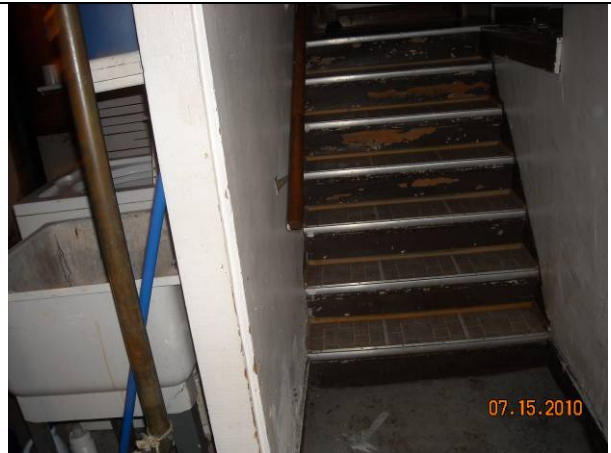
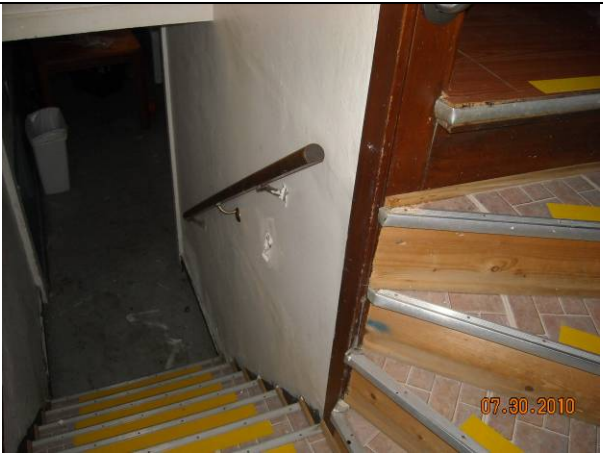
<p>The homeowner had difficulties seeing the stairs due to a decrease in vision. The picture on the right shows contrast tape added to the stairs to make them more visible. The textured tape also helps prevent against slipping.</p>

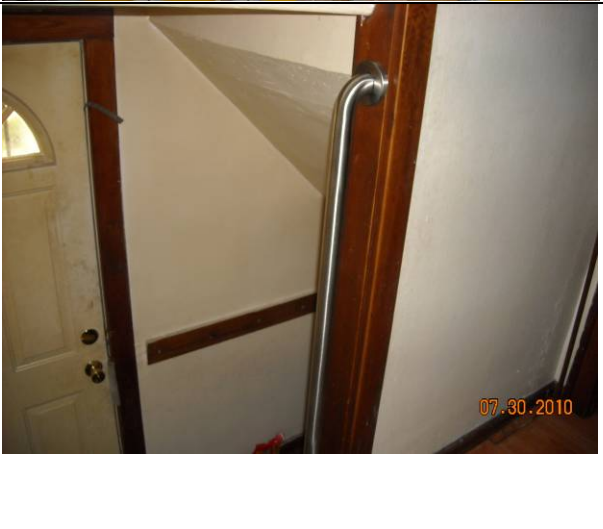
<p>The homeowner could not safely use the top step without additional support. The picture on the right shows the installation of a vertical grab bar. This grab bar assists with stability when declining stairs and supports homeowner when fatigued.</p>

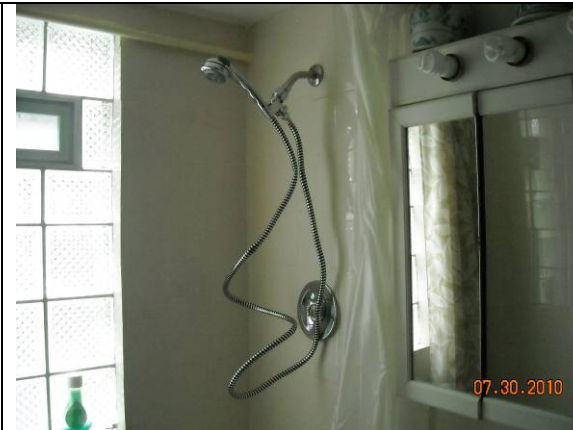
This homeowner had difficulties standing in the shower for long periods of time. The picture on the right reveals the installation of a hand held shower. This addition allows seated showering and easy access to the shower head.

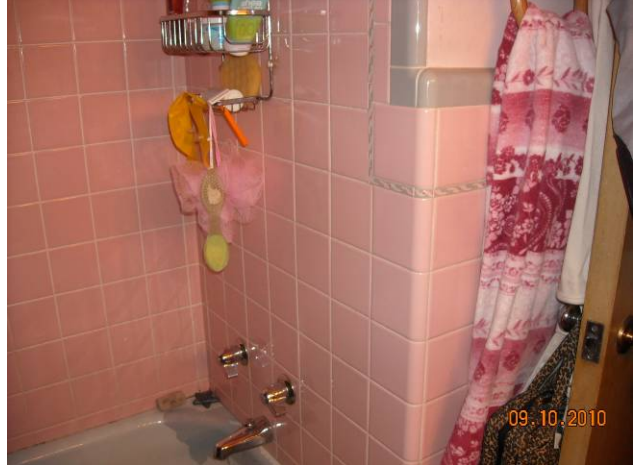
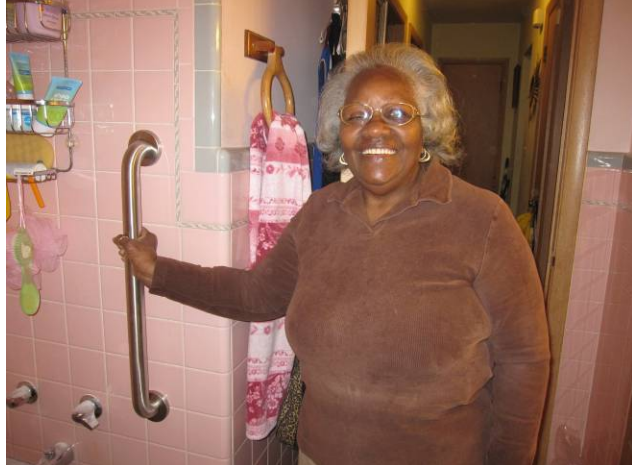
<p>This homeowner needed extra support when stepping in and out of the shower. The picture on the right shows the installed grab bar which will help the homeowner increase safety in their bathroom. The homeowner is happy with the results.</p>
